A quick update regarding some concerns with the Hoyt St Puck remote control. Nothing lasts forever and the Hoyt Puck is no anomaly. Plastic fatigues and breaks, solder joints atrophy when exposed to repeated stresses. It is important to regularly inspect your Puck to ensure it is flight ready.

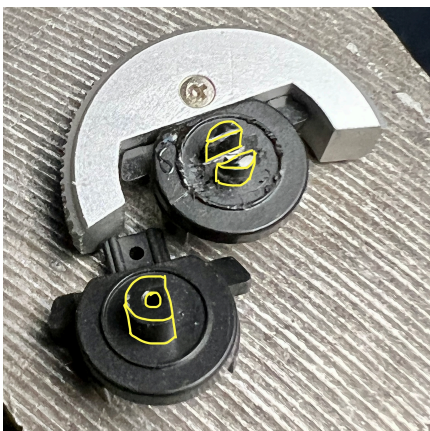
Additionally, Hoyt has reinforced the throttle pin to address the pin breaks we experienced with the first batch of remotes. Anybody with the original two pin configuration was offered a replacement pin on the house. While this modification has immensely improved the durability, a hard fall can still shear this component. This generally results in a non-functional throttle rather than a full throttle event.
